# Construction characterization through Thermography

Shripad G. Shewalkar

May 2025

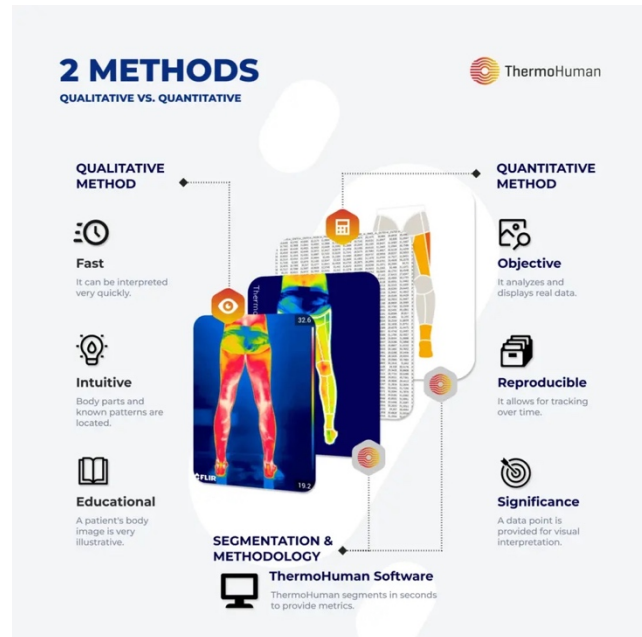
Figure 6 Qualitative and quantitative method of thermography

Qualitative thermography relies on the analysis of thermal patterns to discover anomalies and their location, while quantitative thermography uses temperature measurement values to quantify the degree of severity of the anomaly.

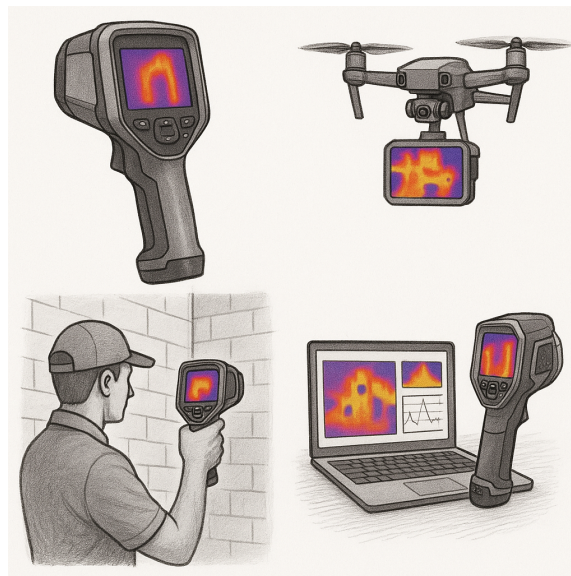
Figure 9 Example of Equipments used Thermal Imaging

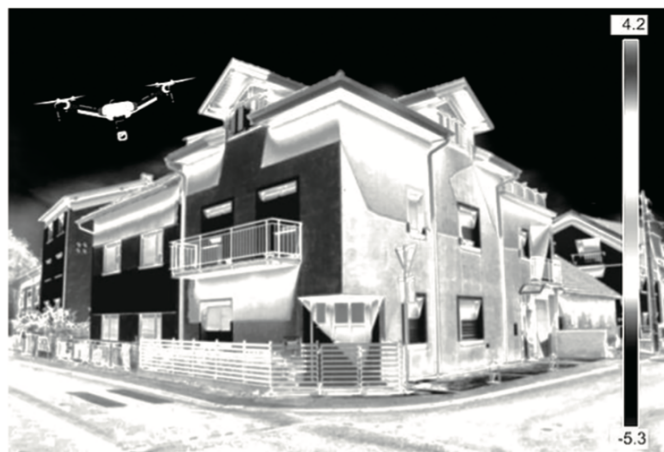
Figure 14 Thermal Imaging using a Drone

Unmanned Aerial Vehicles (UAVs), or drones, have emerged as a revolutionary platform for conducting thermographic inspections in civil engineering. They address a key limitation of ground-based surveys – the ability to quickly cover large or difficult-to-reach areas without the need for scaffolding or lane closures. UAV-based infrared thermography has been tested on structures such as long-span bridges, high-rise building façades, and expansive heritage sites. By mounting a thermal camera on a drone, engineers can capture heat maps of infrastructure from vantage points that were previously impractical. For example, a drone can fly under a bridge or hover alongside a tall building to image areas that inspectors cannot physically access easily. The promise of UAV-IRT is faster data collection and improved safety (keeping inspectors on the ground), but it also introduces new challenges. Flight instability, environmental factors, and data processing complexity can affect results. In this context, a real-world demonstration was undertaken to evaluate the feasibility of UAV-mounted thermography for structural inspections. The application was twofold: (1) a concrete bridge deck survey using a drone instead of a truck, and (2) a survey of a historic masonry structure's walls using a drone to cover upper sections. The aim was to assess if the UAV approach could detect the same kind of defects (delaminations, moisture zones, cracks) identified by traditional IRT, and to understand the practical considerations (flight conditions, image quality, etc.) in the field. (Meola, 2013; Shrestha et al., 2025) (Milovanović & Pečur, 2014) (ThermoElite Inc., n.d.)
